TECHNICAL NOTE 2538

MECHANICAL AND CORROSION TESTS OF SPOT-WELDED  
ALUMINUM ALLOYS

Fred M. Reinhart  
National Bureau of Standards

Washington  
December 1951

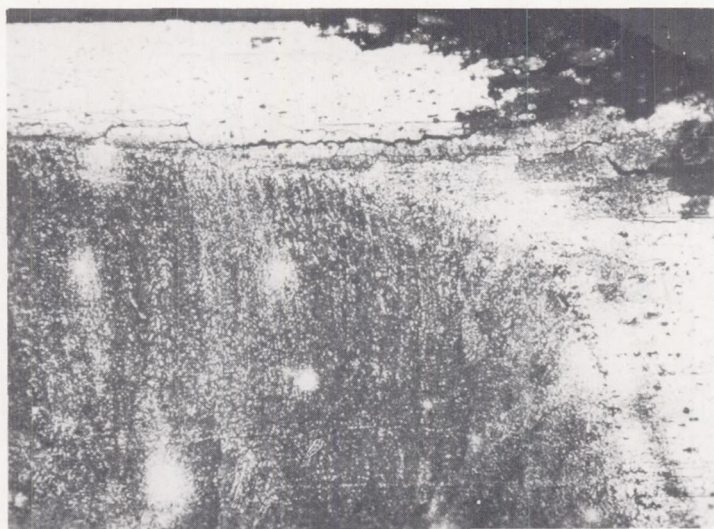
Figure 48.- Same area as in figure 47 showing intergranular corrosion attack, X100. Keller's etch, 30 seconds.

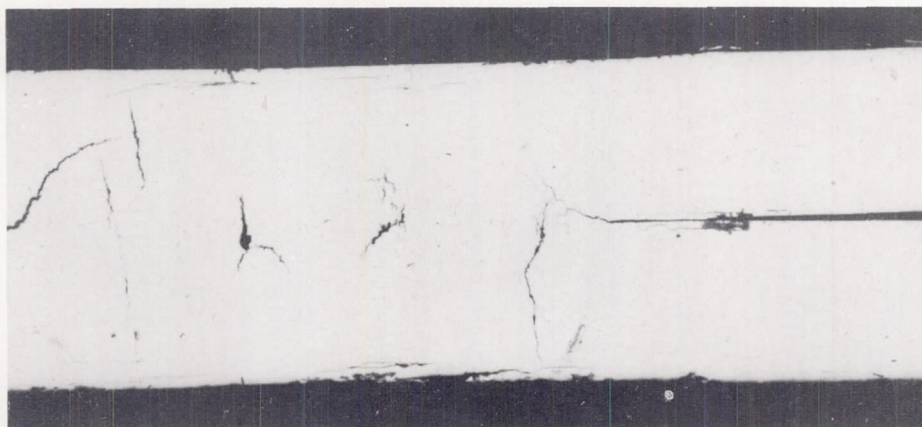
Figure 49.- Severe weld fracturing and intergranular corrosion attack on inner and outer surfaces of sample X-13, XB75S-T6, welded with dirty electrodes and exposed 1 year to sea coast atmosphere, X20. Unetched.

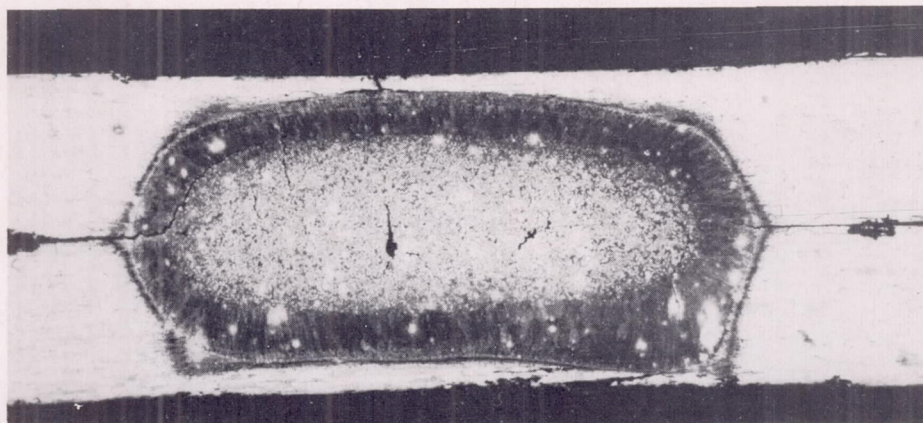
Figure 50.- Etched appearance of macrostructure shown in figure 49, X20. Keller's etch, 30 seconds.

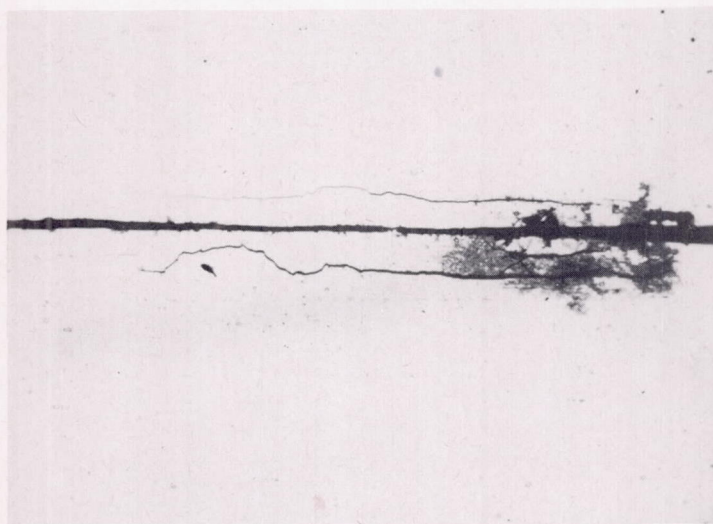
Figure 51.- Intergranular attack along faying surfaces in region at extreme right in figures 49 and 50, X100. Unetched.

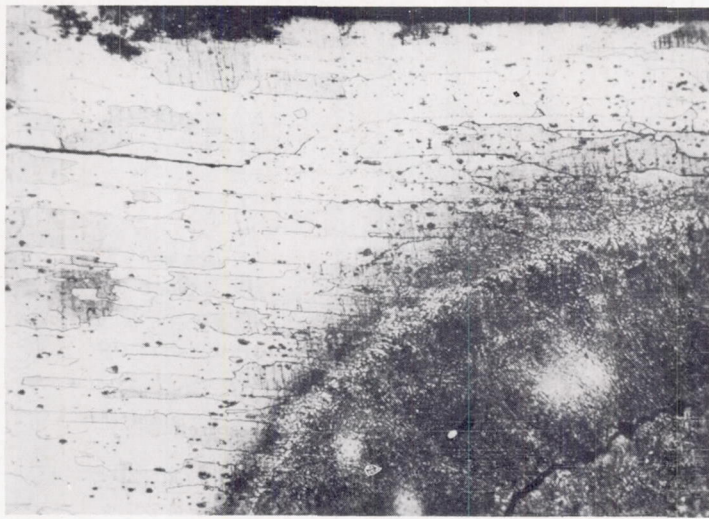
Figure 52.- Region from upper left corner of nugget (fig. 50) showing intergranular attack, X100. Keller's etch, 30 seconds. Note grain-boundary precipitate, visible at this low magnification, along which attack is proceeding from left to right.
